Hydrological field research factsheet – Amalva Peatland – Lithuania

Technical report of the DESIRE project – action 3.2

Hydrological field research factsheet – Amalva Peatland – Lithuania. Technical report of the DESIRE project – action 3.2

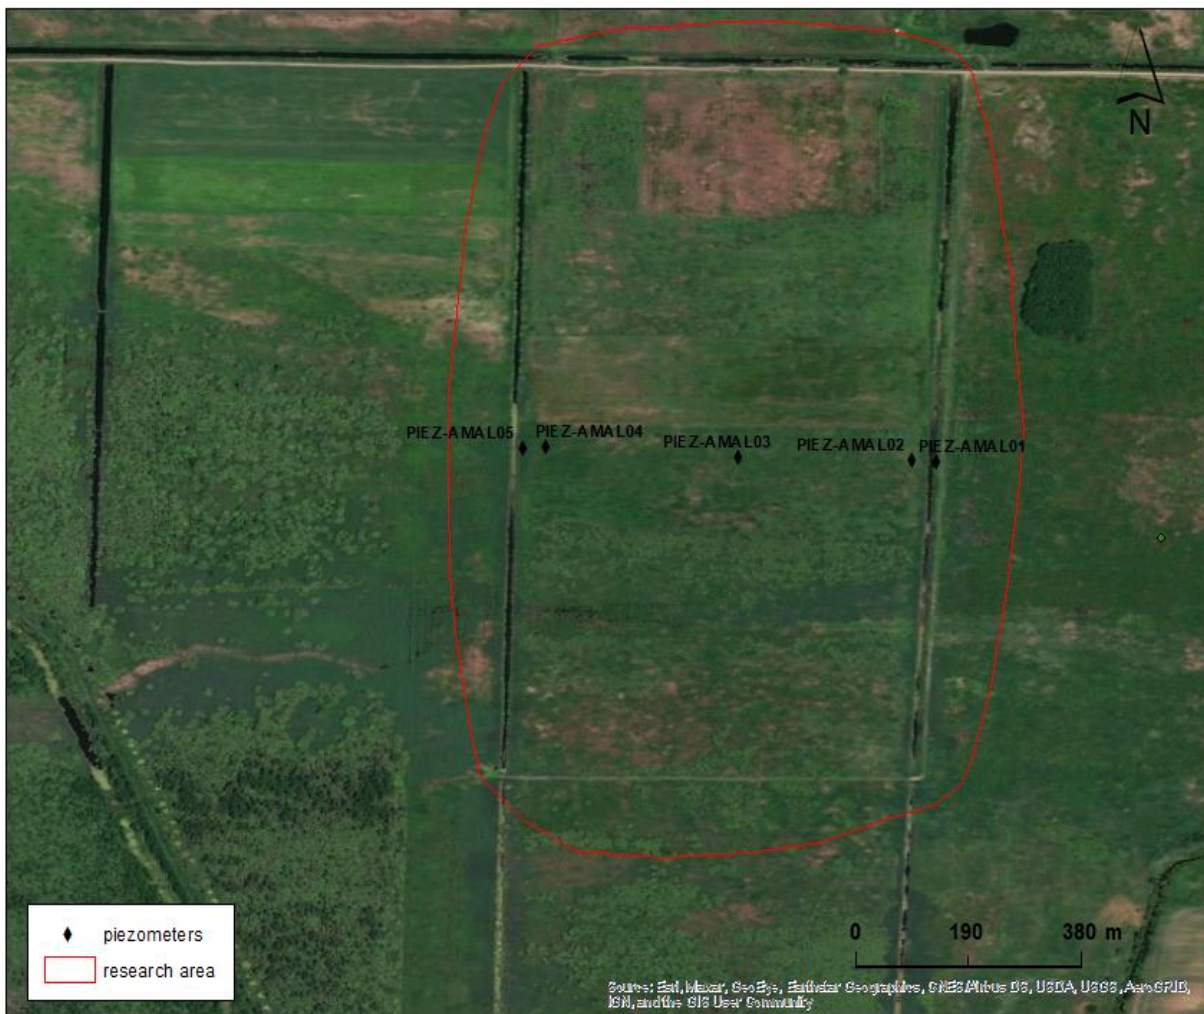
Figure 2. Location of the piezometric transect in Amalva Peatland, Lithuania

The location of the research site, installed piezometers and drainage ditches is shown in Figure 2. Table 1 summarizes locations of the piezometers and technical parameters.

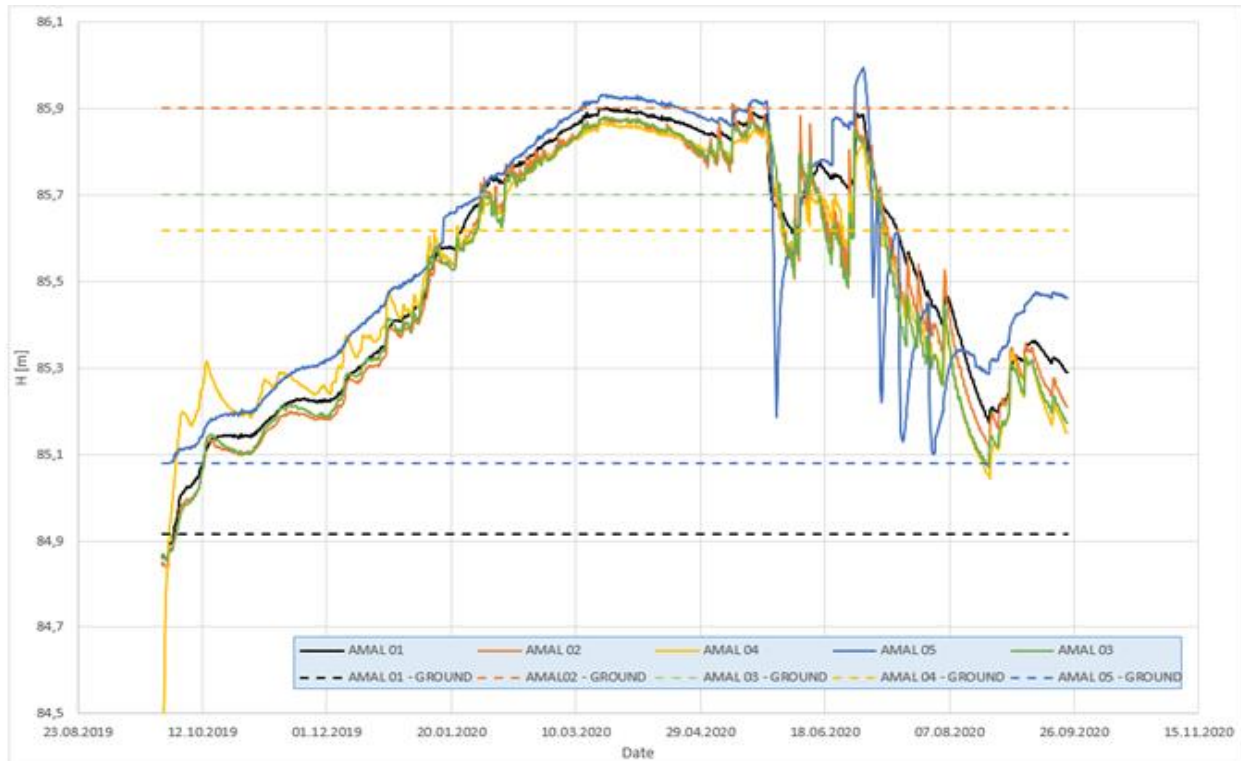
Figure 6. Variability of the groundwater table in the piezometers on the Amalva Peatland (Žuvintas BR., LT). Measurement period: 2019-09-25 - 2020-09-23.

Water table in the Amalva peatland remained below ground level for most of the measurement period. Fig. 6 shows the variation of water table in time for individual piezometers and the statistics are contained in Table 2. In the piezometer AMAL02, the groundwater level remained below ground level almost throughout the measurement period. The percentage of all measurement days with water table above ground for piezometers AMAL03 and AMAL04 is similar. Piezometers AMAL01 and AMAL05 measure the variation of water level in the ditches.

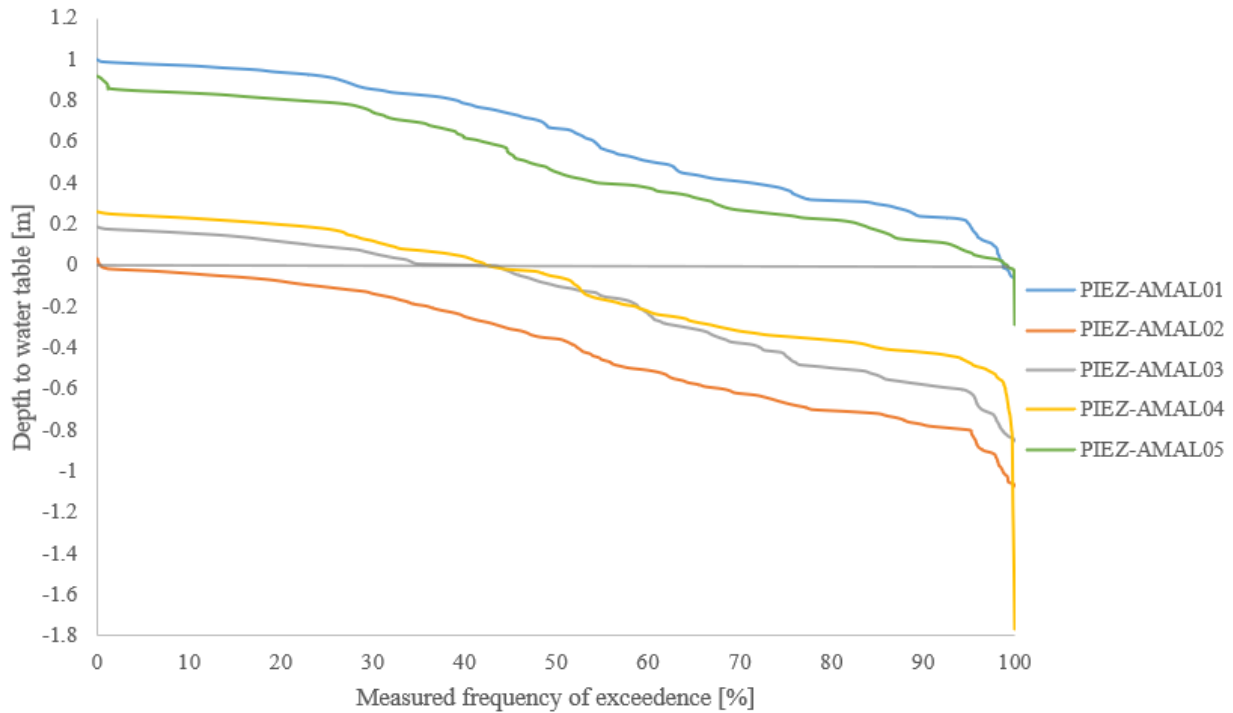
Figure 7. Water-level-duration curves for 5 piezometers located in the Amalva Peatland.

Figure 7 shows water-level-duration curves for 5 piezometers located in the Amalva Peatland. Axis X represents measured frequency of exceedance where depth to the water table is higher or equal to value from axis Y.
