DESIRE – DEvelopment of Sustainable adaptive peatland management by restoration and paludiculture for nutrient REtention and other ecosystem services in the Neman river catchment

WP 3.4

Results of groundwater modeling – Gromovo Peatland (RU)

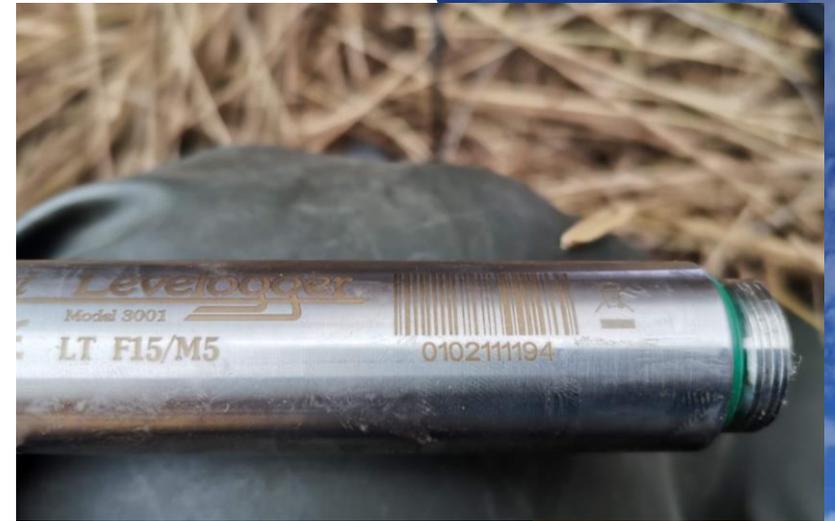
Gromovo - observations

- K1_22.26
- K2_22.09
- K3_22.13
- K3P_22.12
- K4_22.40

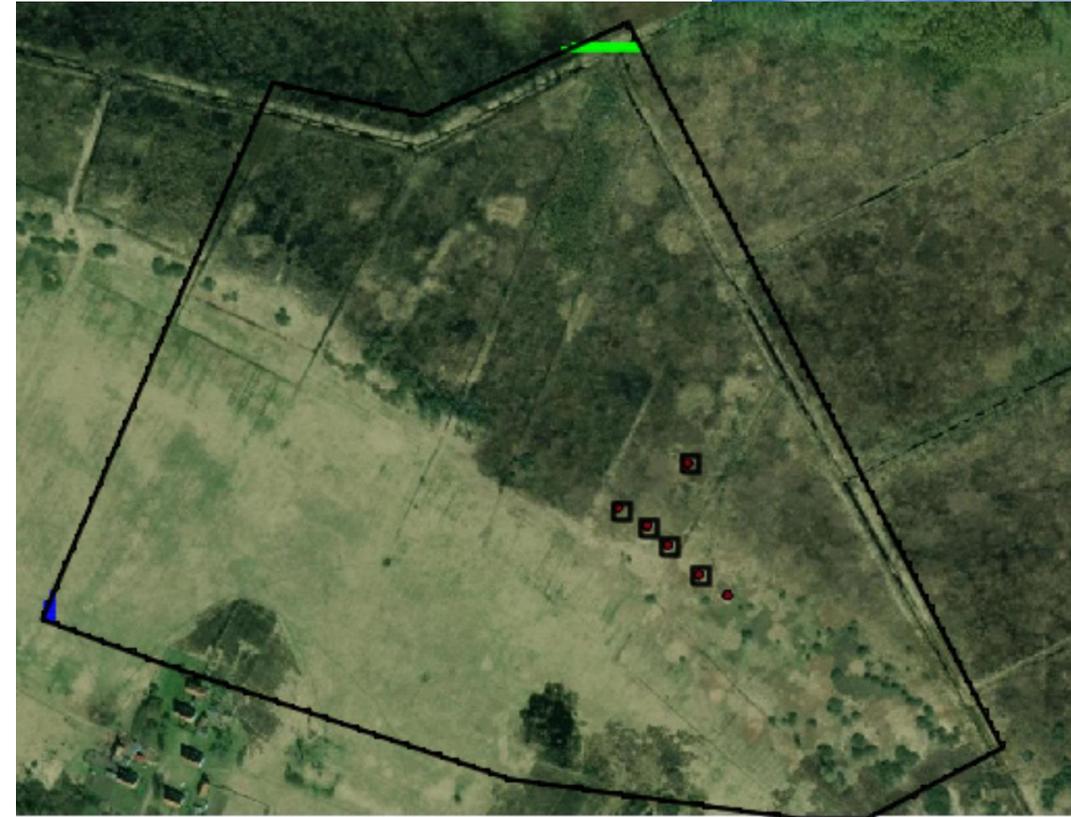
Gromovo – groundwater flow modeling - MODFLOW

- Groundwater recharge – P-ET (0.000351 m/d)
- Kx peat (calibrated – 0.073 m/d)
- Kx sand (calibrated – 15.1 m/d)
- Conductance of ditches – 0.1 m/d
- Depth of ditches – 0.2 m
- Simulation period: 01.11.2019-31.10.2020

Tab. 1. Comparison of average observed and modelled groundwater levels (values in m asl)

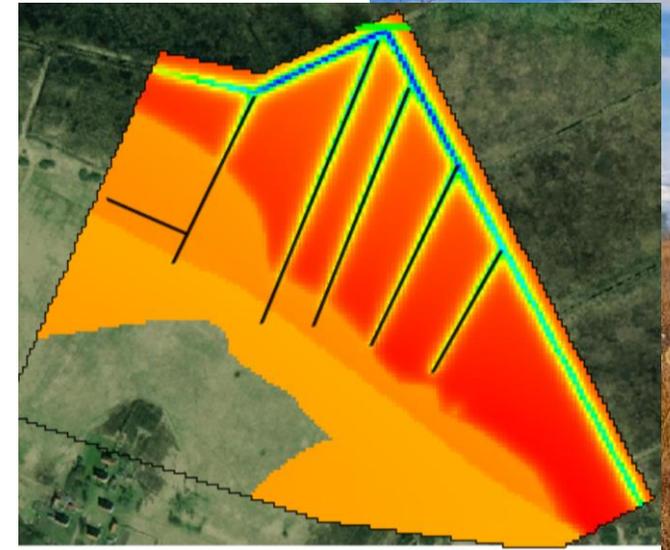
Gromovo – modeling - MODFLOW

- Scenario 1 – Renewal of drainage ditches (1 m deep, clean), no modification of river regime

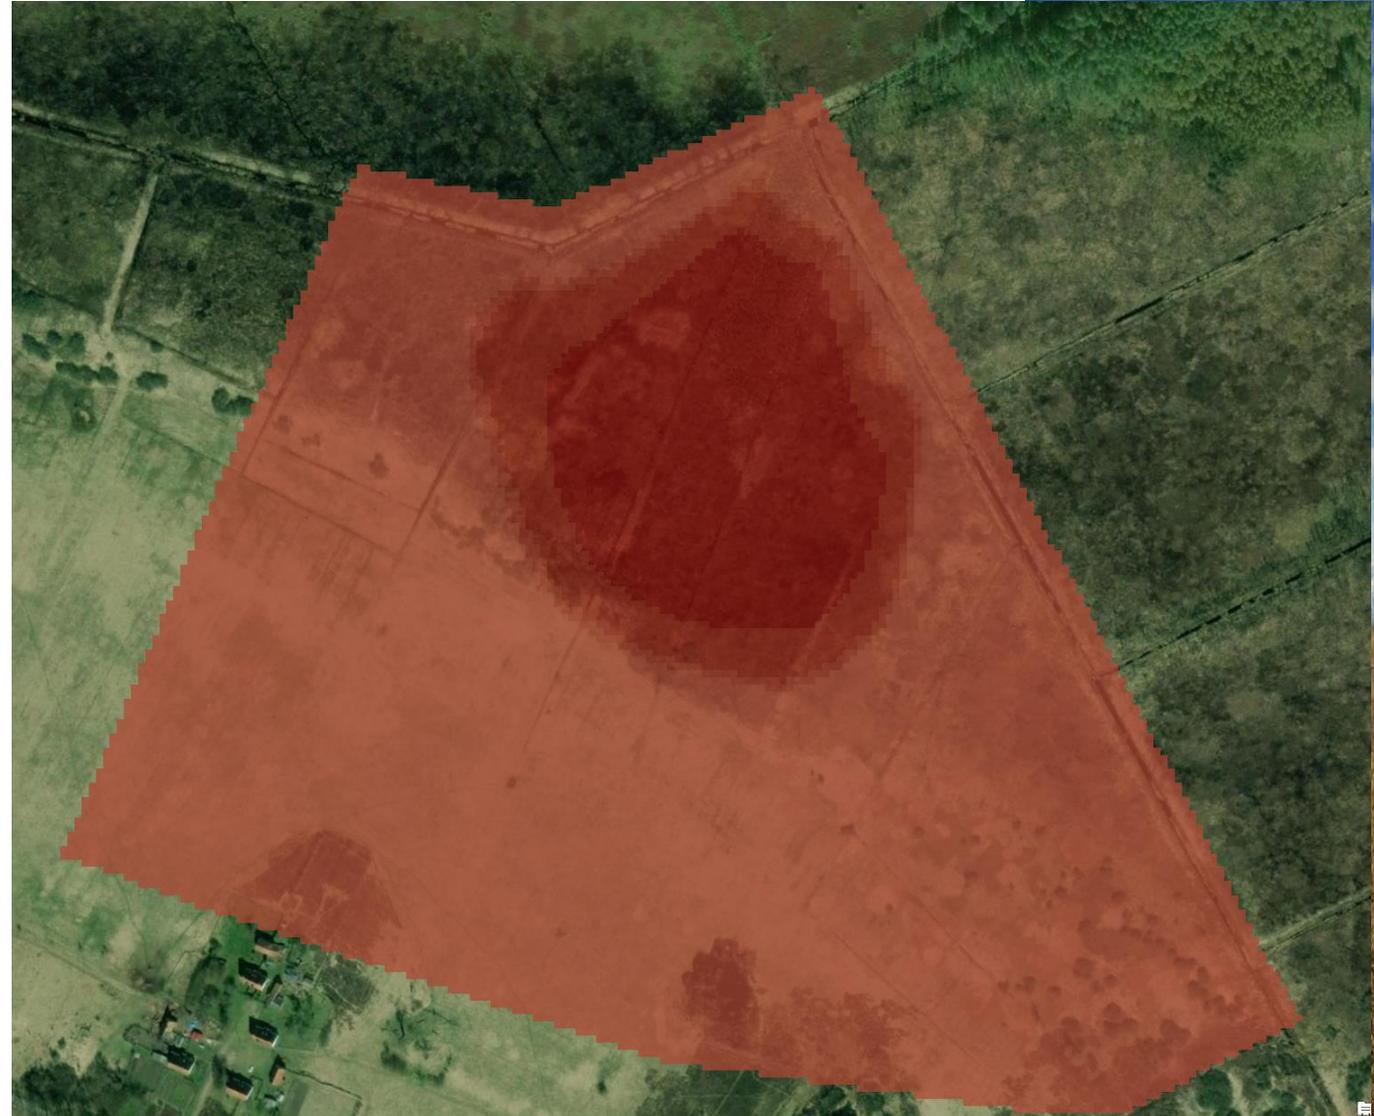
Gromovo – modeling - MODFLOW

- Areal decline of groundwater level;
- The highest – within the core zone of ditches
